SALT LAKE CITY STREAMS, UTAH

LITTLE DELL LAKE
FOUNDATION REPORT

APRIL 1995

U.S. ARMY CORPS OF ENGINEERS
SACRAMENTO DISTRICT
SACRAMENTO, CALIFORNIA

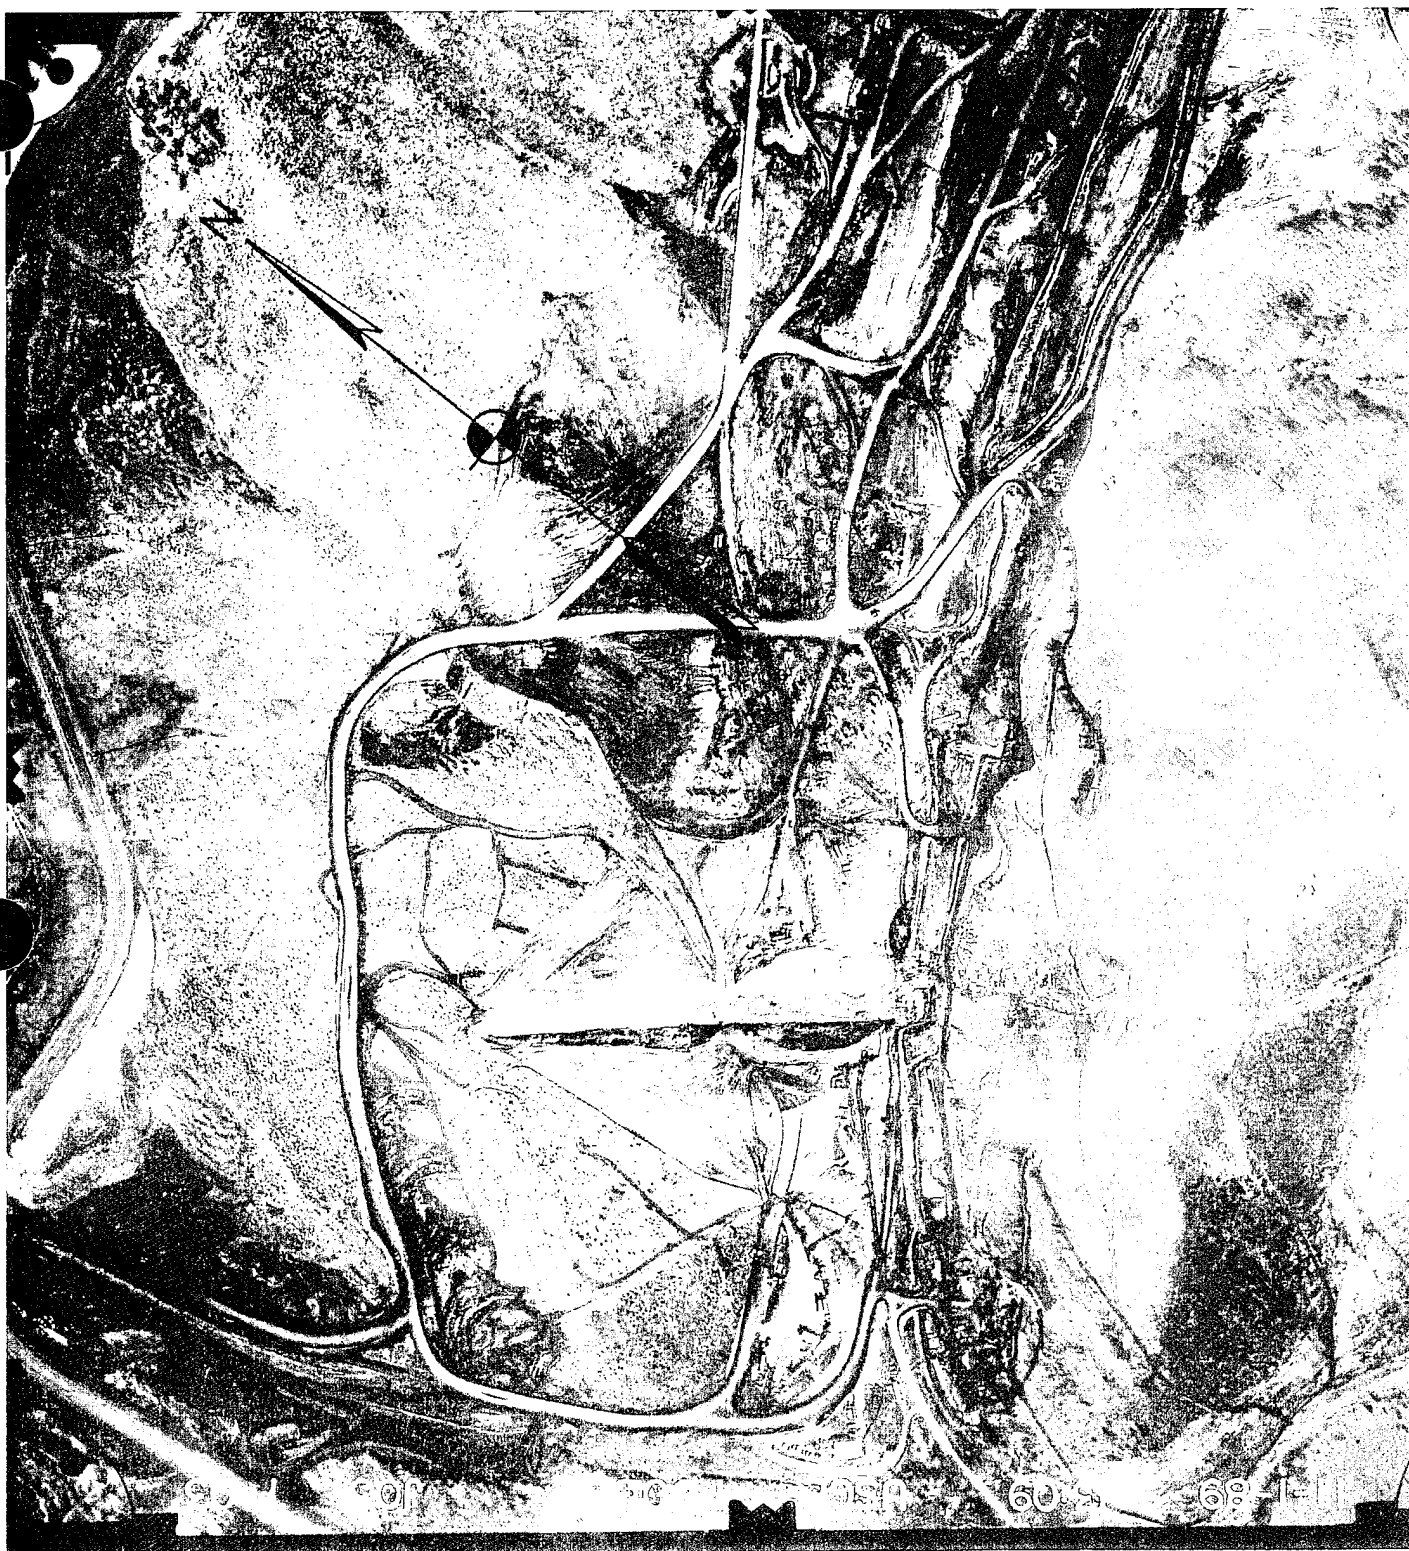
PHOTO 2. AERIAL PHOTO OF DAMSITE ON 11/1/89.

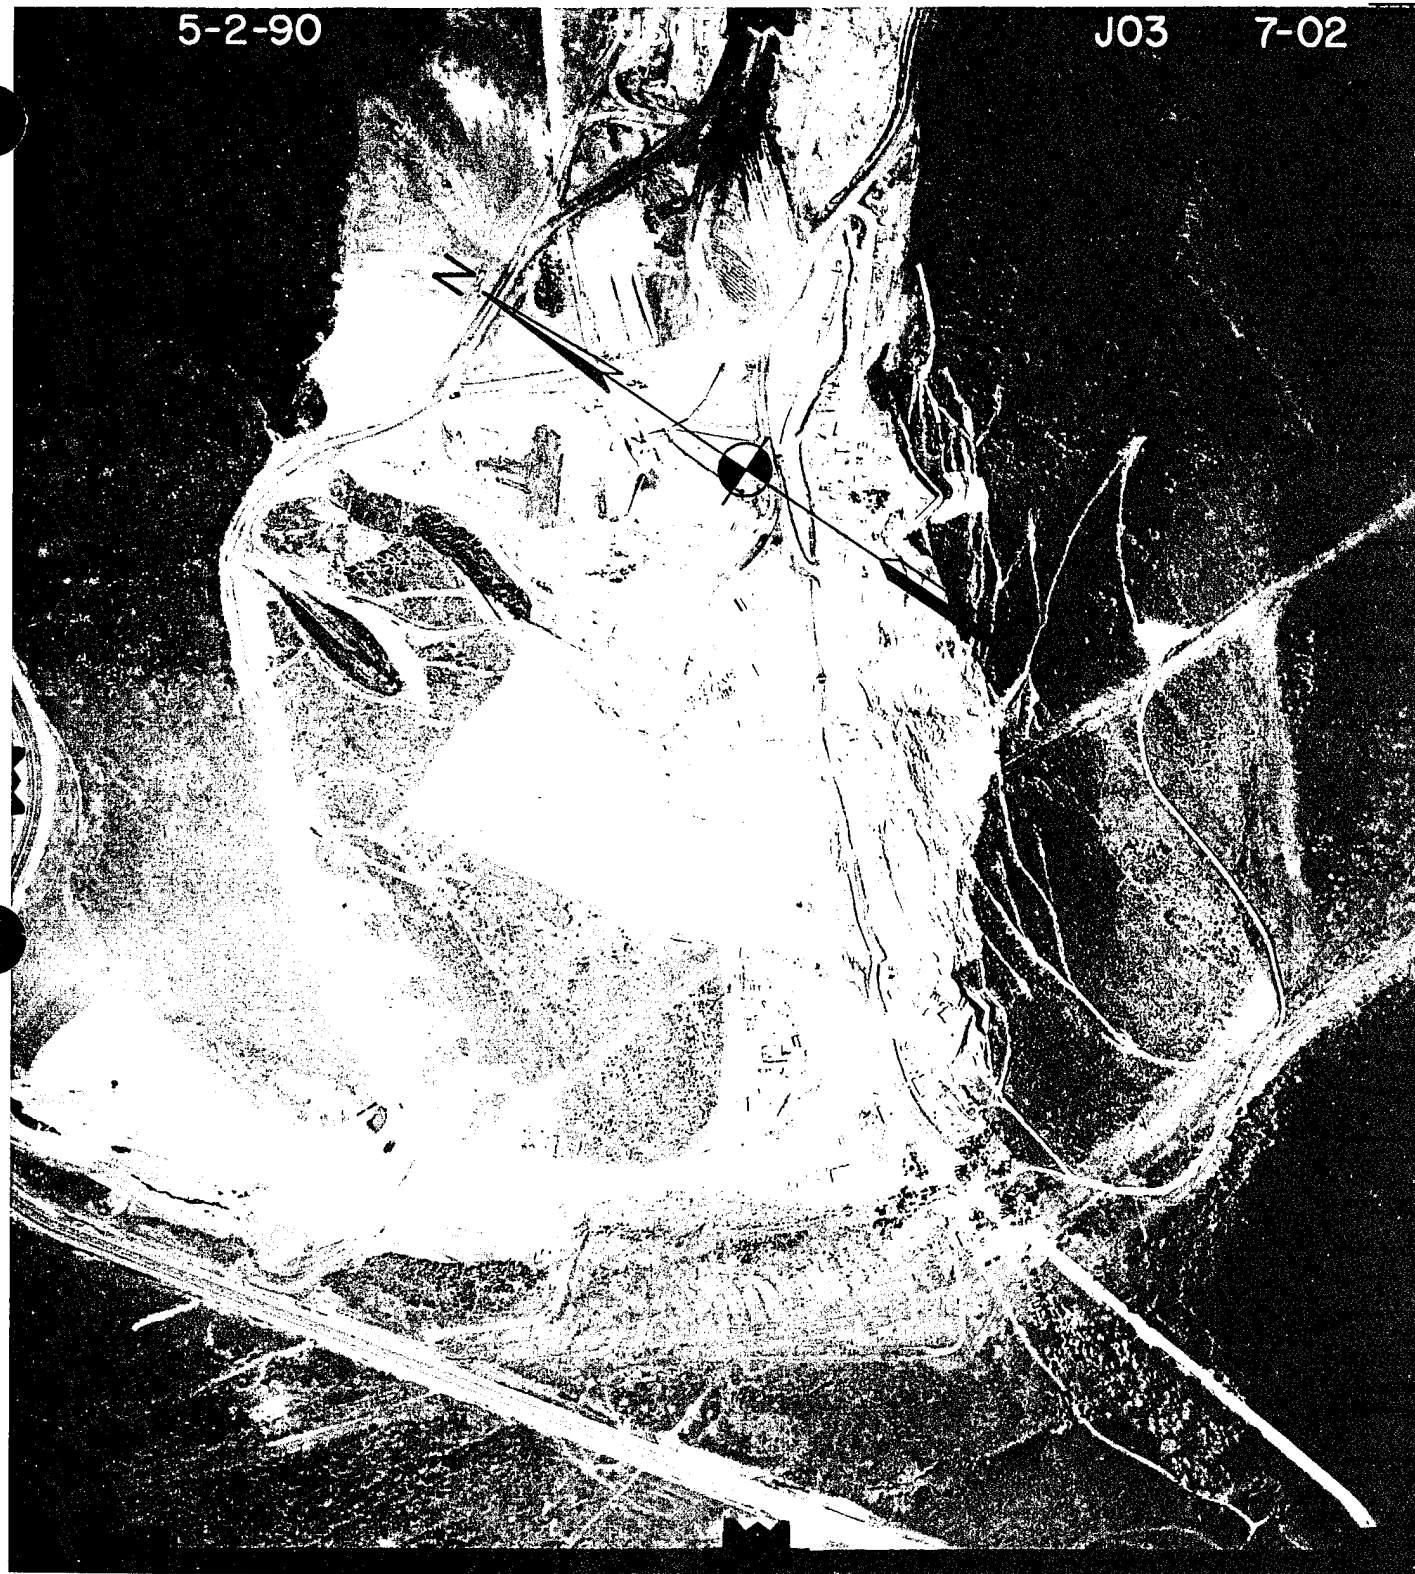
PHOTO 3. AERIAL PHOTO OF DAMSITE ON 5/2/90.

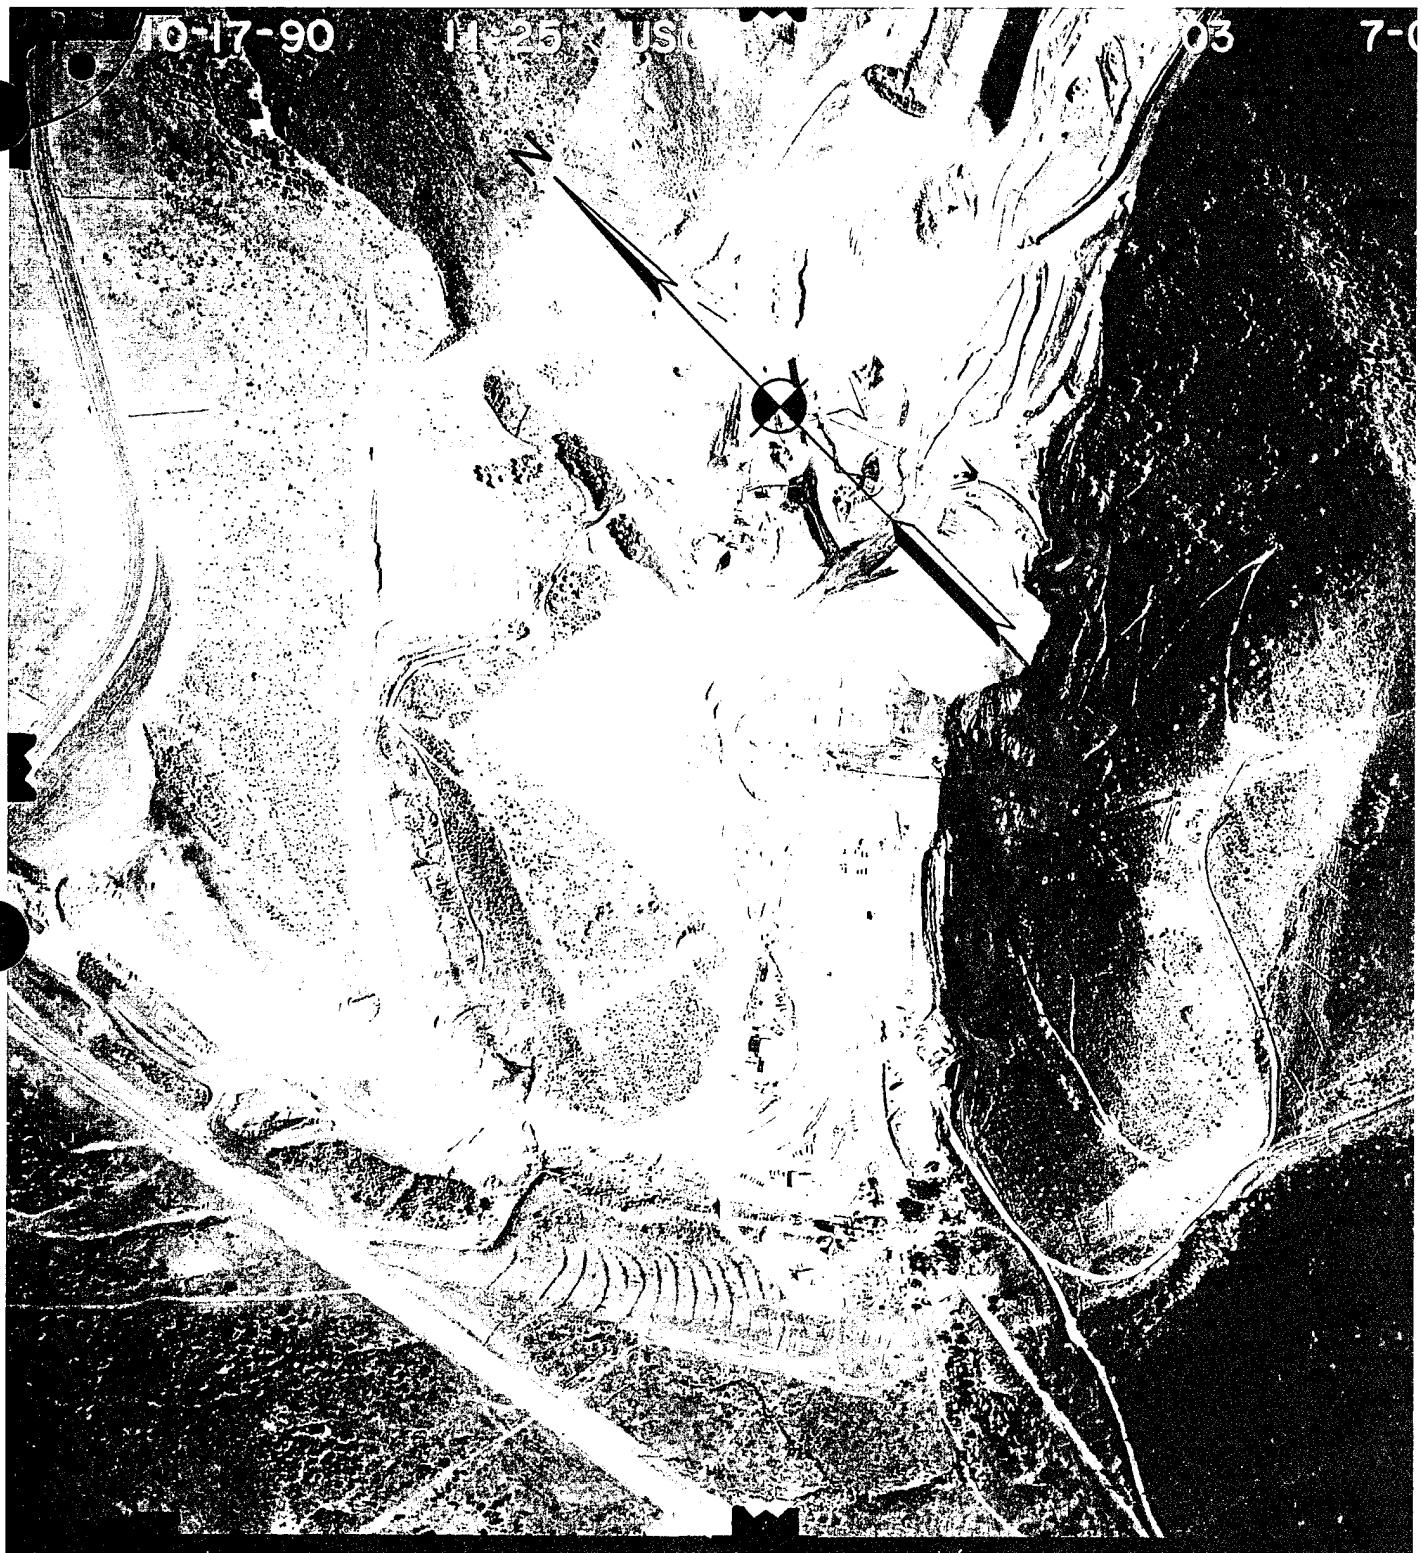
PHOTO 4. AERIAL PHOTO OF DAMSITE ON 10/17/90.

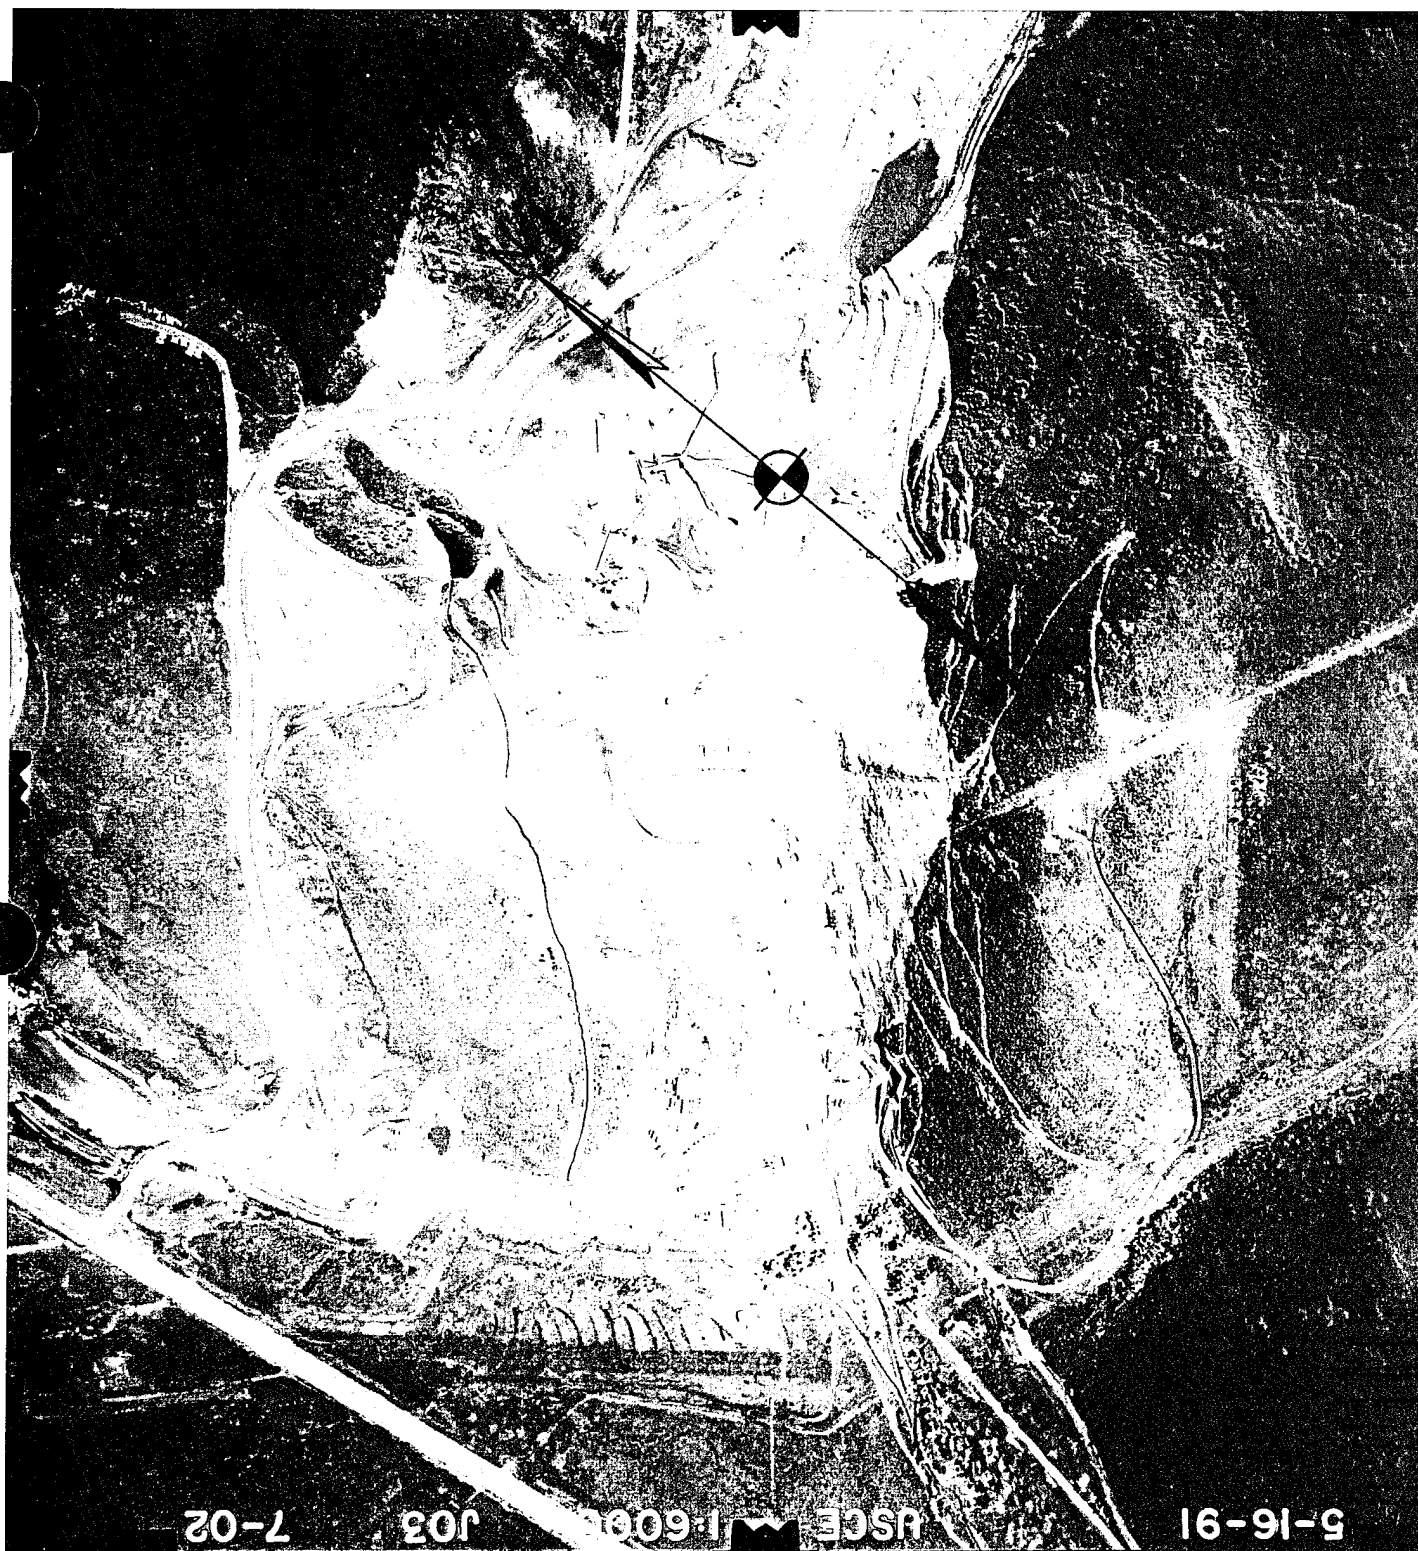
PHOTO 5. AERIAL PHOTO OF DAMSITE ON 05/16/91.

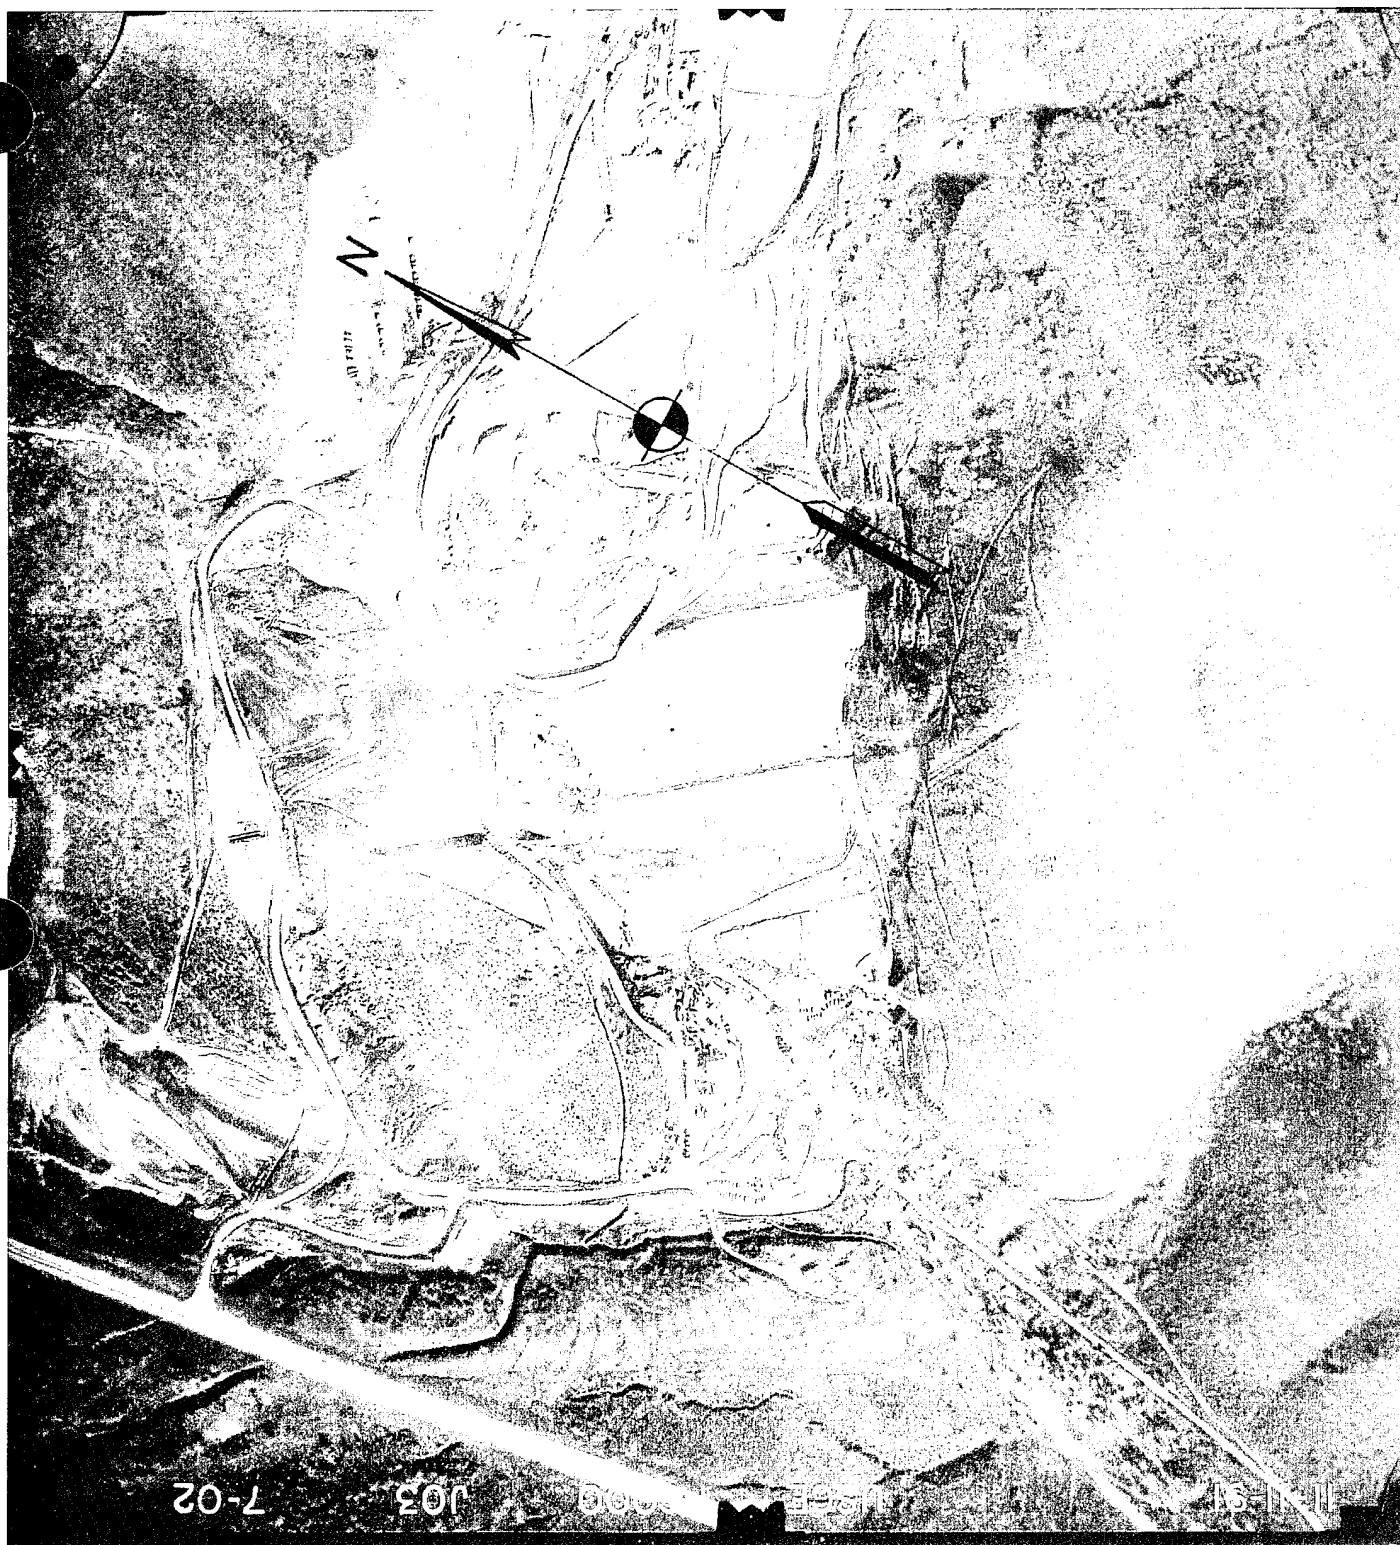
PHOTO 6. AERIAL PHOTO OF DAMSITE ON 11/11/91.

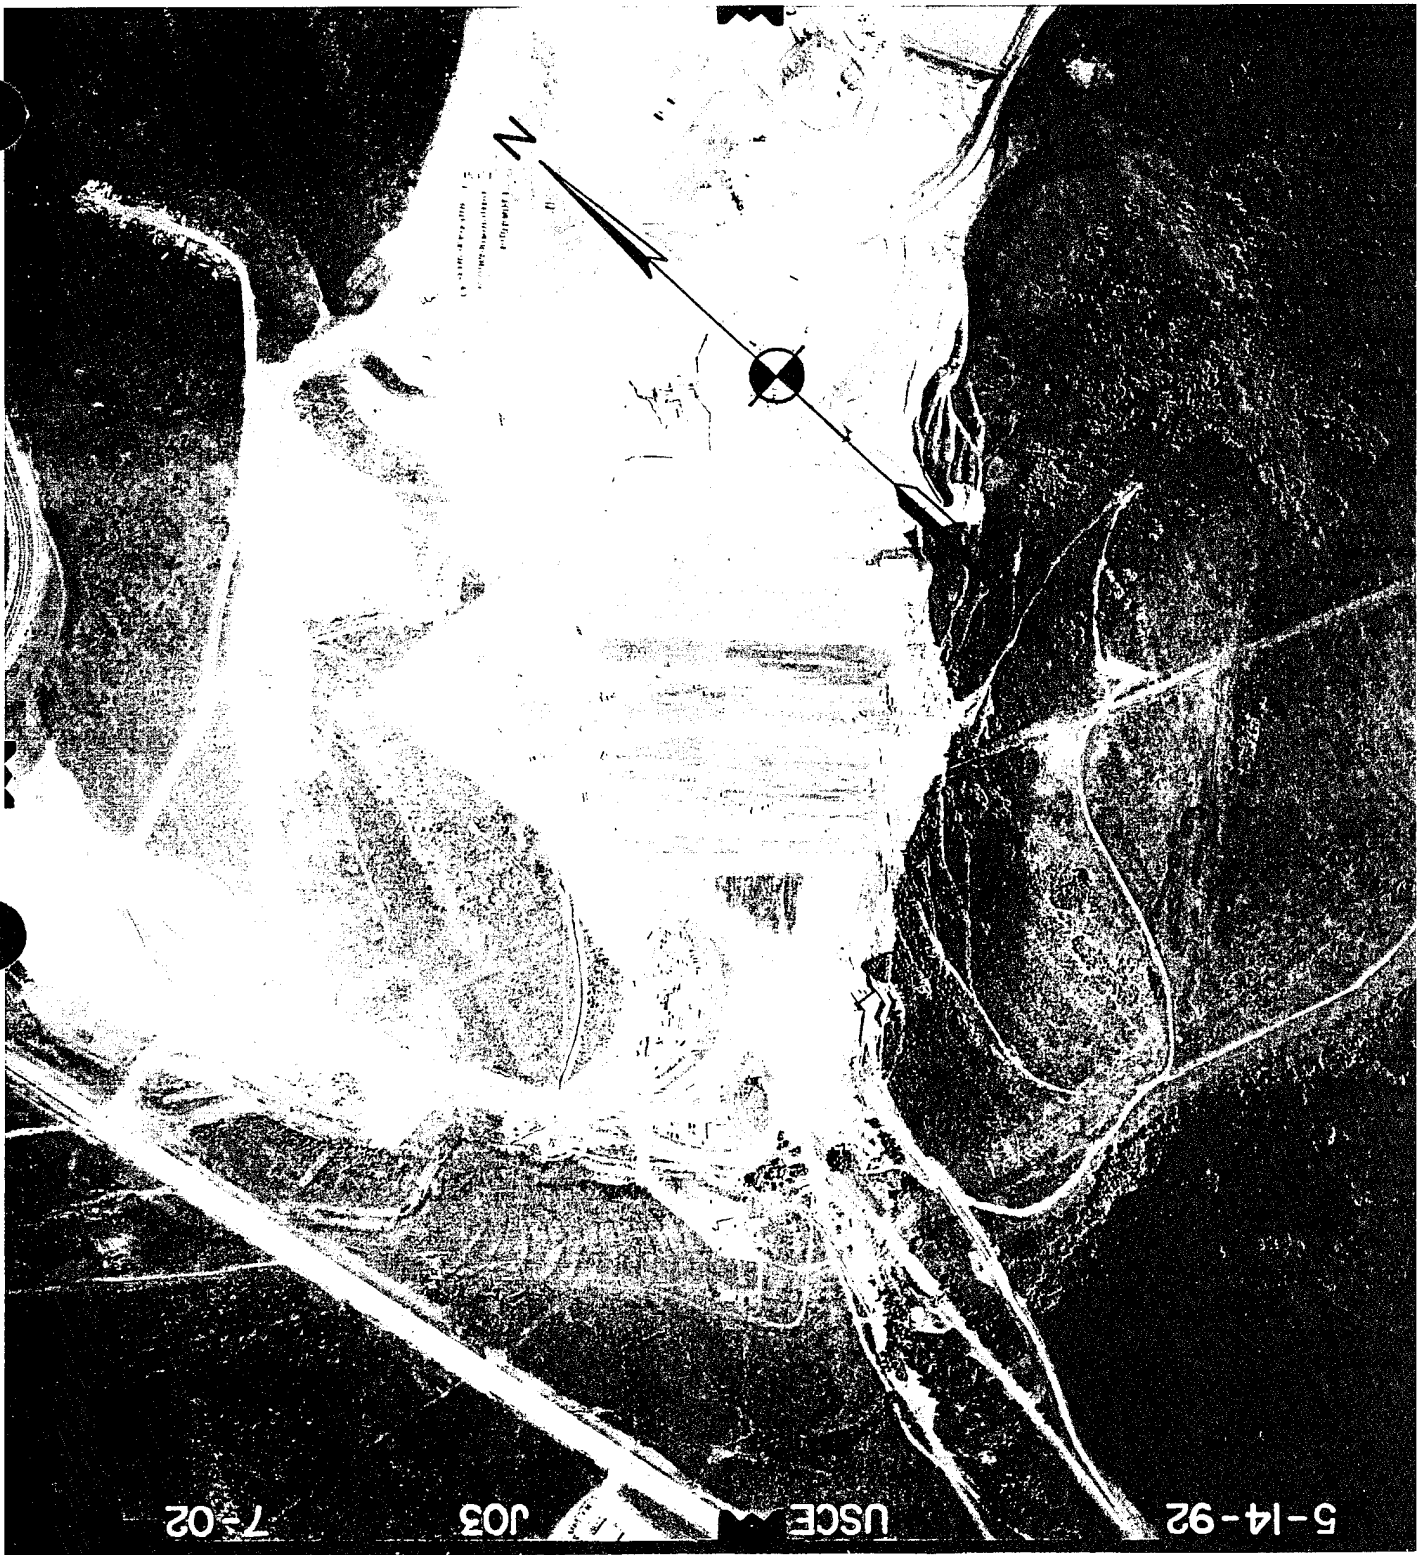
PHOTO 7. AERIAL PHOTO OF DAMSITE ON 05/14/92.

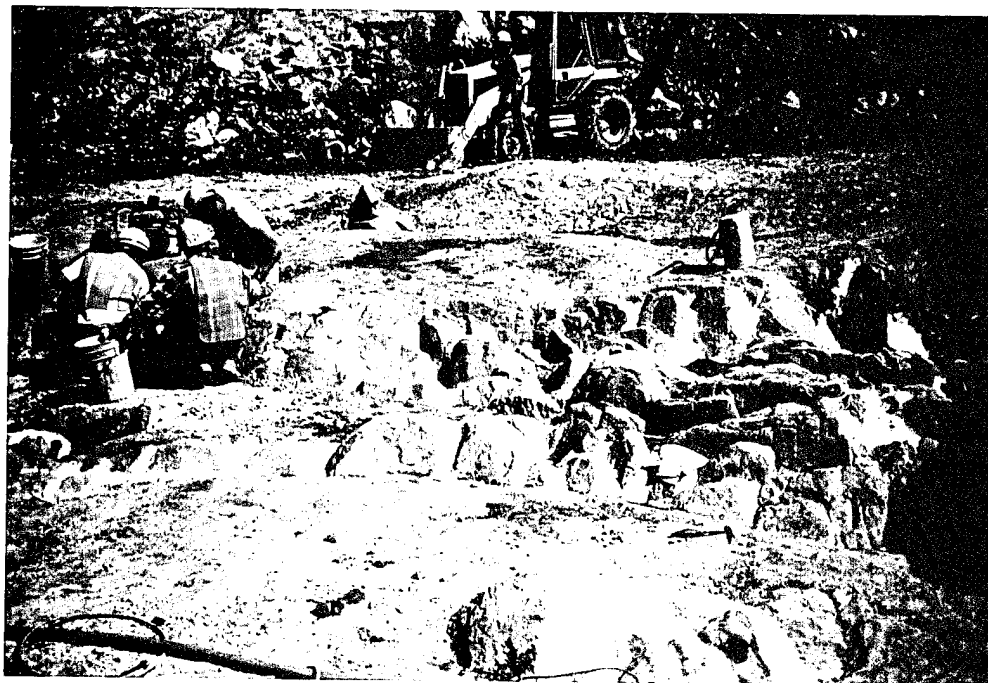
PHOTO CT5. Looking left near Sta. 15+00 in core trench at joints that have been mortared. The white color resulted from curing compound which was initially applied to the surface of the mortar. This practice was later discontinued.

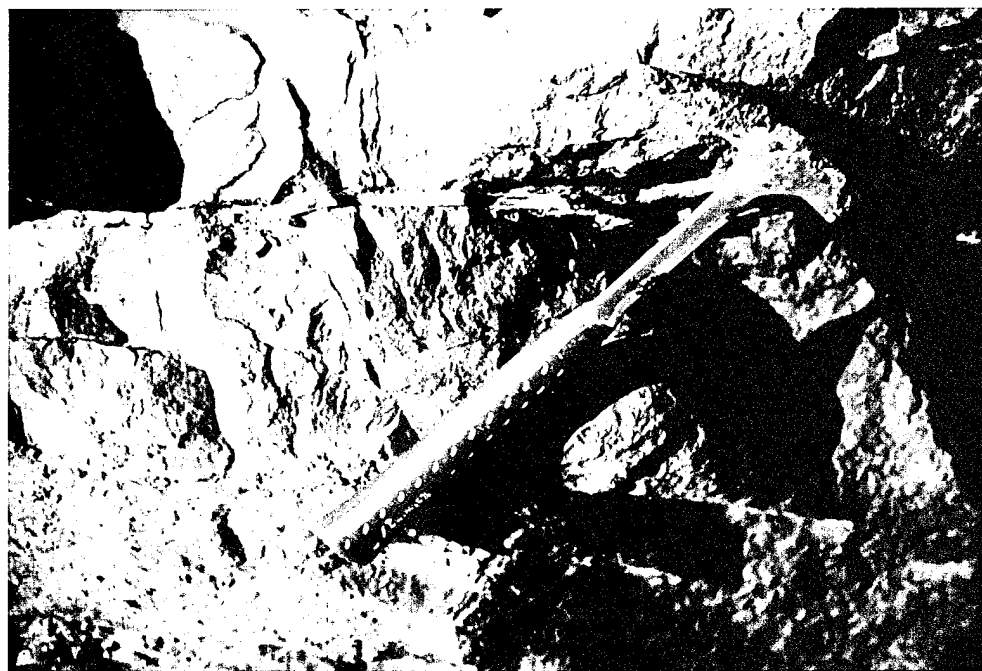
PHOTO CT6. Grout filling in fracture near foundation grout curtain in core trench.

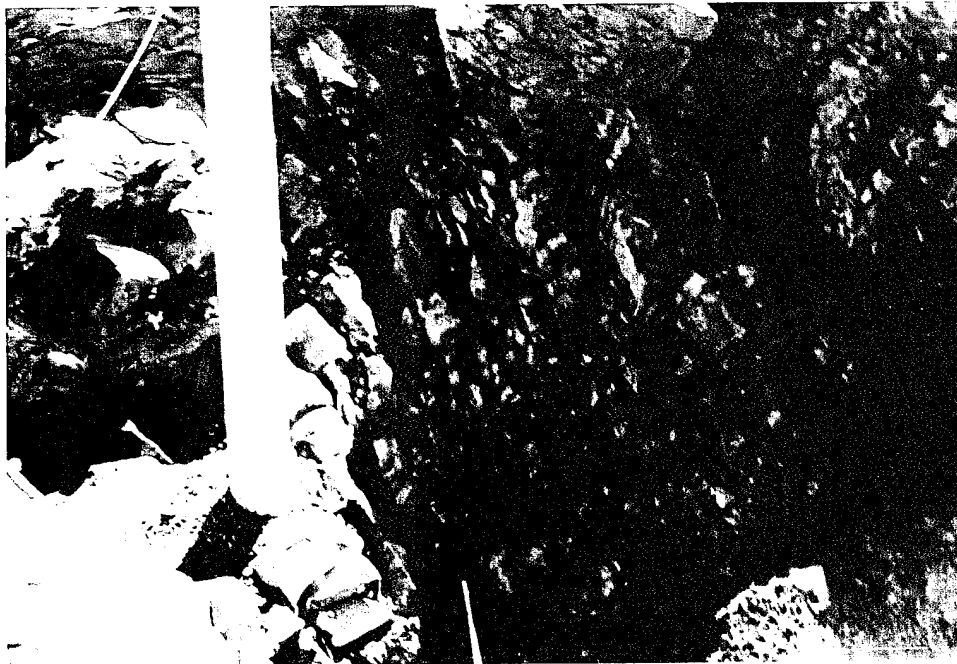
PHOTO CT8. Looking left and down into sump described above. The bags contain dry cement. Dental concrete was placed around the PVC. When the fill exceeded the head in the sump the PVC and gravel were grouted.

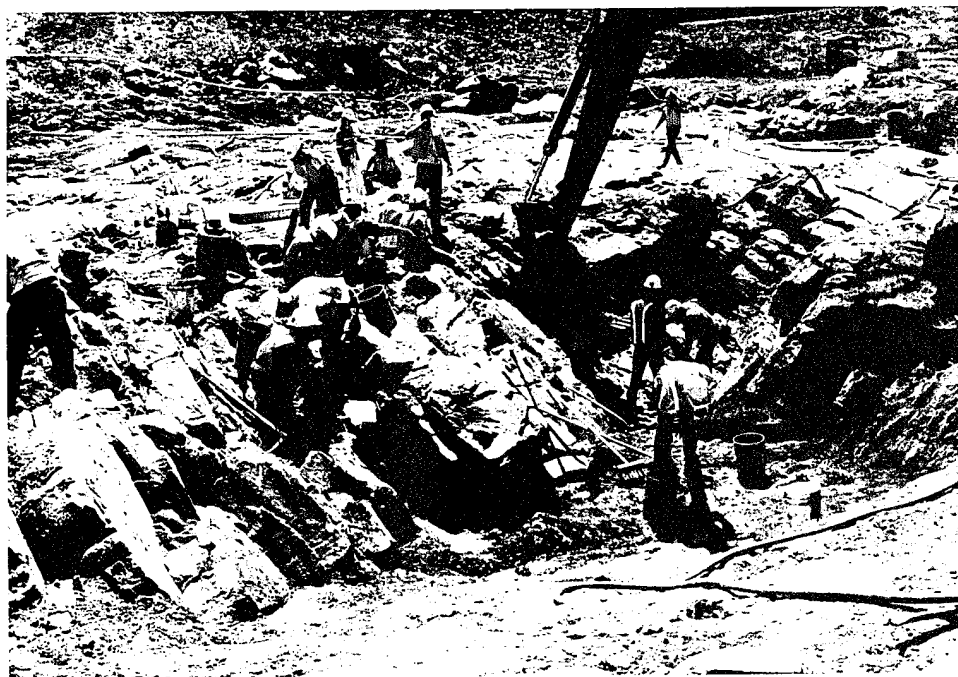
PHOTO CT11. Looking downstream at cleanup of core trench, preparing to place leveling concrete. Backhoe bucket is at about Sta. 15+40, 5 feet upstream of the dam axis.

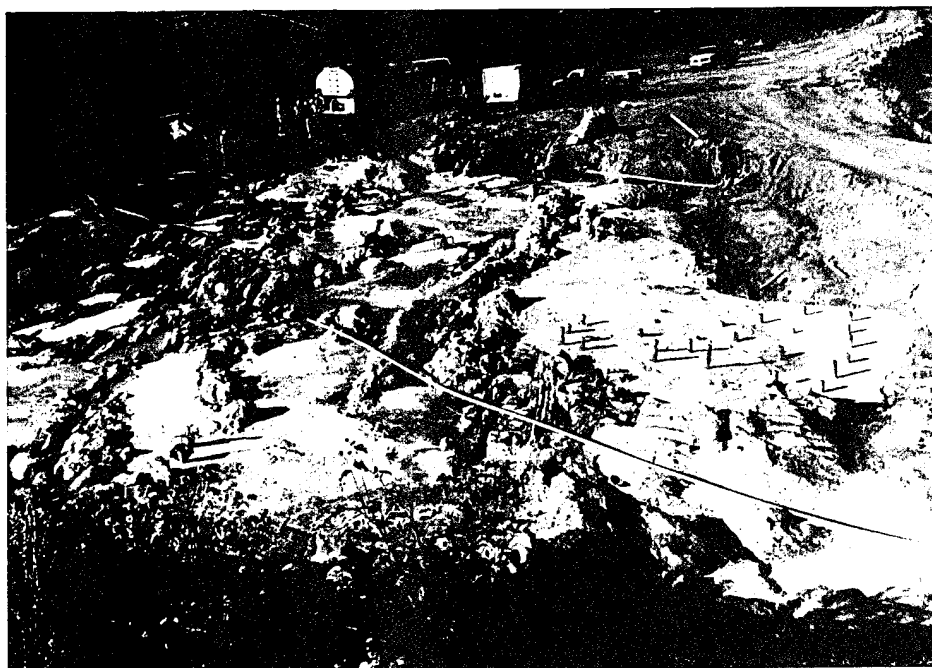
PHOTO CT12. Same area as previous photo taken from further away. Grout nipples are in deepest area seen in the previous photo. Photo covers the core trench invert from Sta. 14+60 to 15+50.

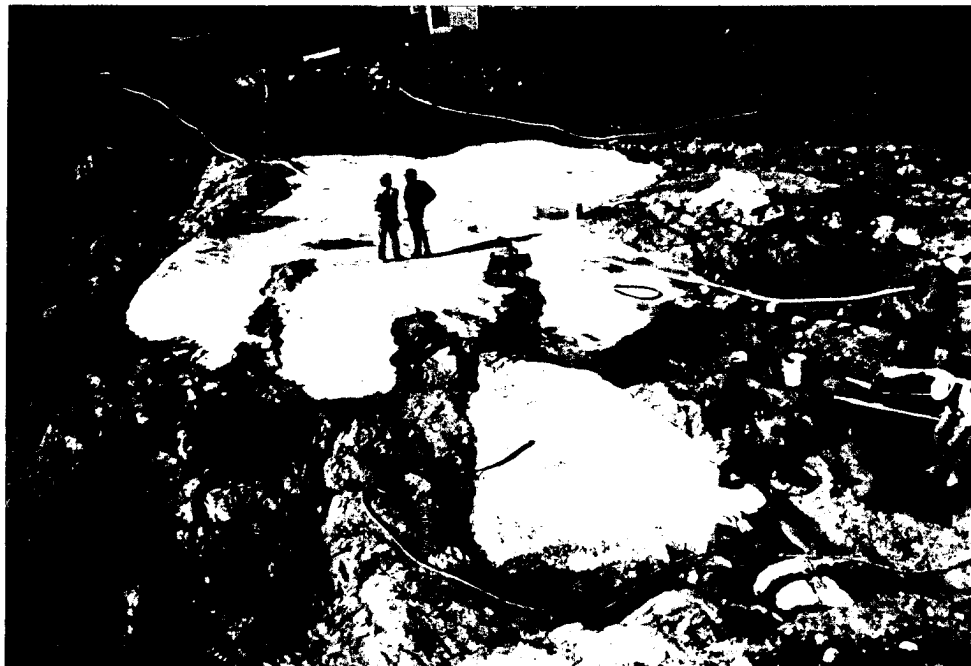
PHOTO CT13. Looking downstream at the core trench foundation and leveling concrete on 9/13/90. Sta. 16+00 is in the middle of the photo. Refer also to the foundation treatment map.

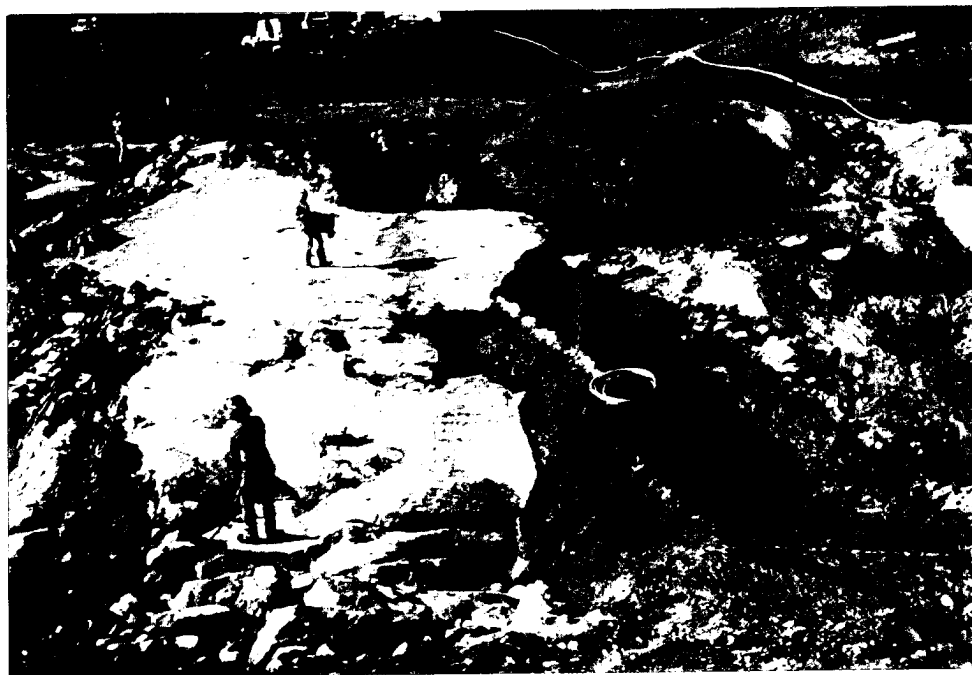
PHOTO CT14. Looking downstream at the core trench foundation. Sta. 15+50 is in the middle of the photo.

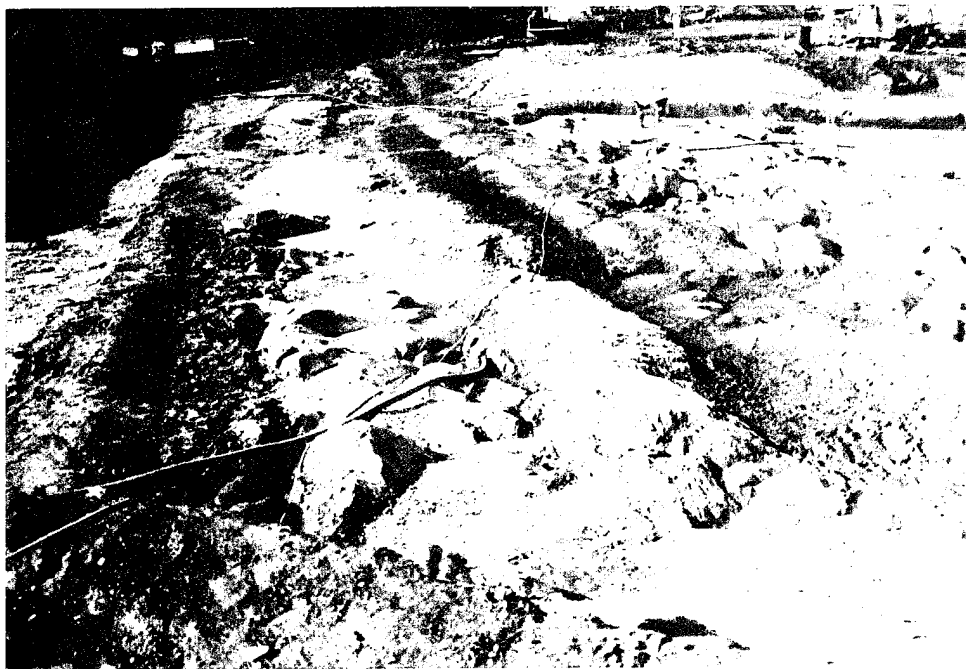
PHOTO CT16. Looking downstream at the core trench foundation. Sta. 14+50 is in the middle of the photo.

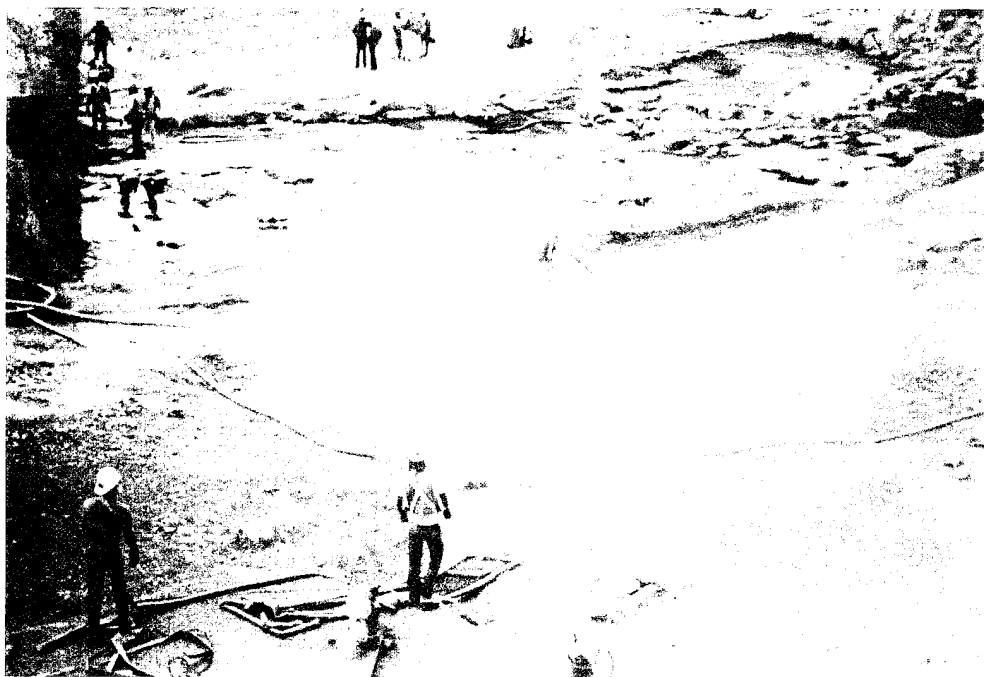
PHOTO CT18. Looking right from about Sta. 13+80. Contractor's crew is using a high pressure air nozzle to remove loose material from the core trench foundation at about Sta. 14+75 before beginning the first impervious fill placement.

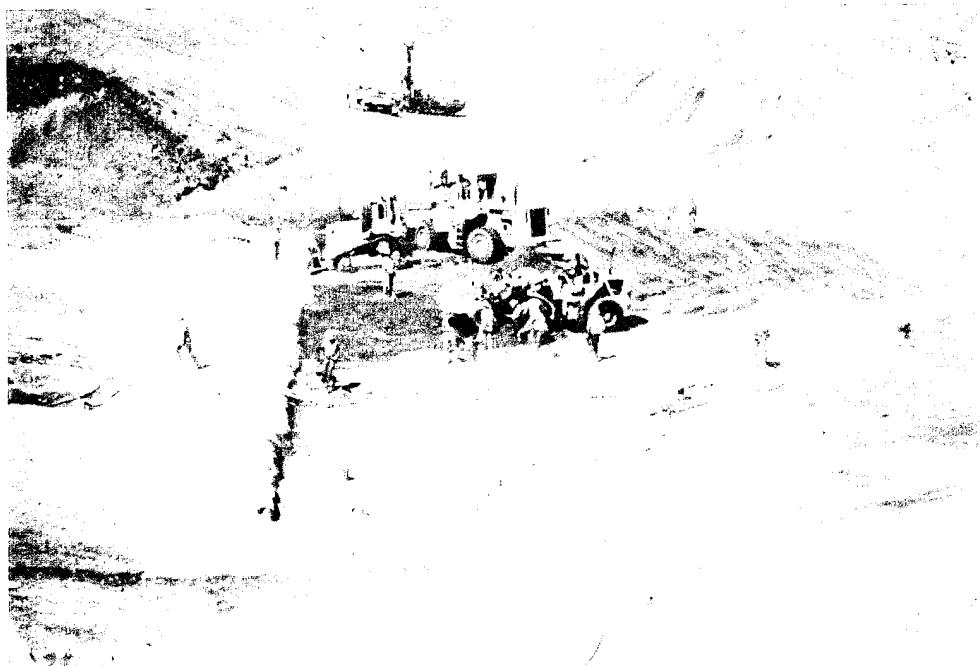
PHOTO CT19. The first impervious fill placement at about Sta. 15+50 to 16+00.

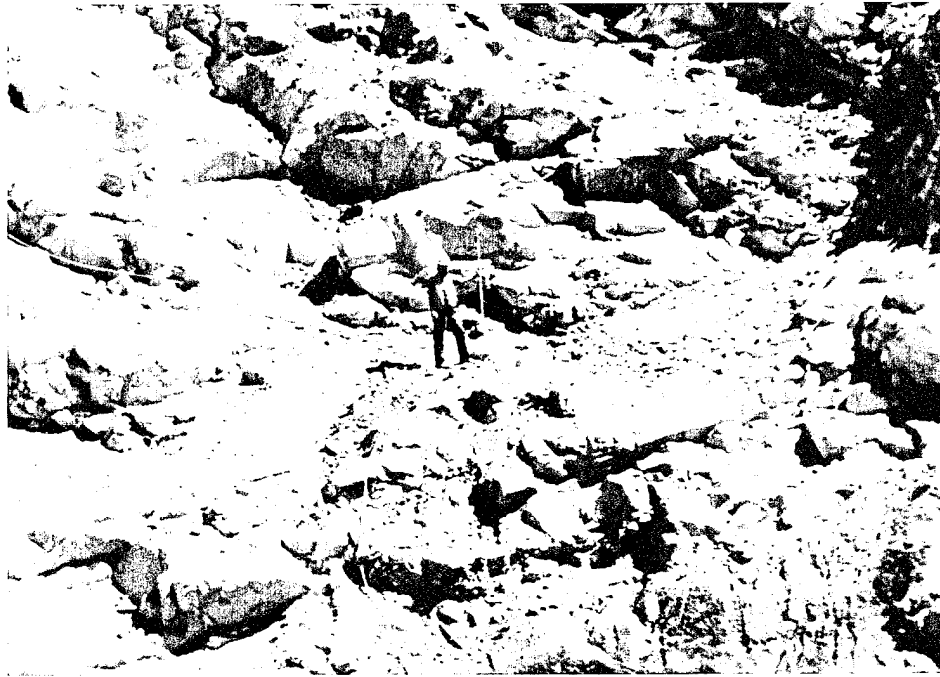
PHOTO CT20. Looking left at the core trench foundation between Sta. 12+00 and 13+00, before final cleanup. Note overhangs resulting from rock breaking along bedding planes in hard sandstone layers. Corps of Engineers Geologist is in the center of the photo.

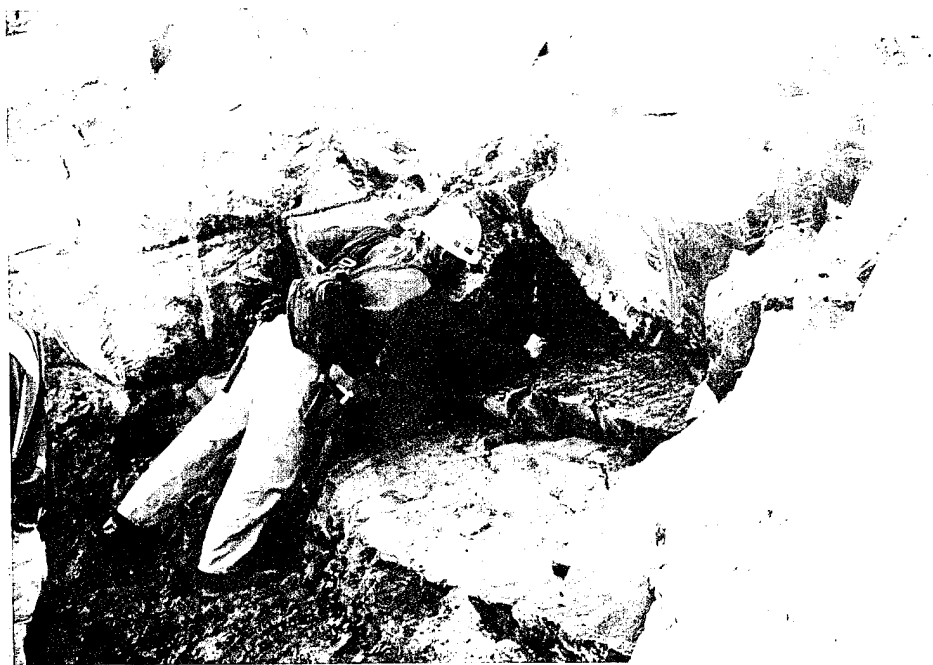
PHOTO CT21. Looking left at the left abutment core trench foundation at the toe of the upstream cut-slope. Inspection cleanup in preparation for placing concrete fillet to correct an overhang.

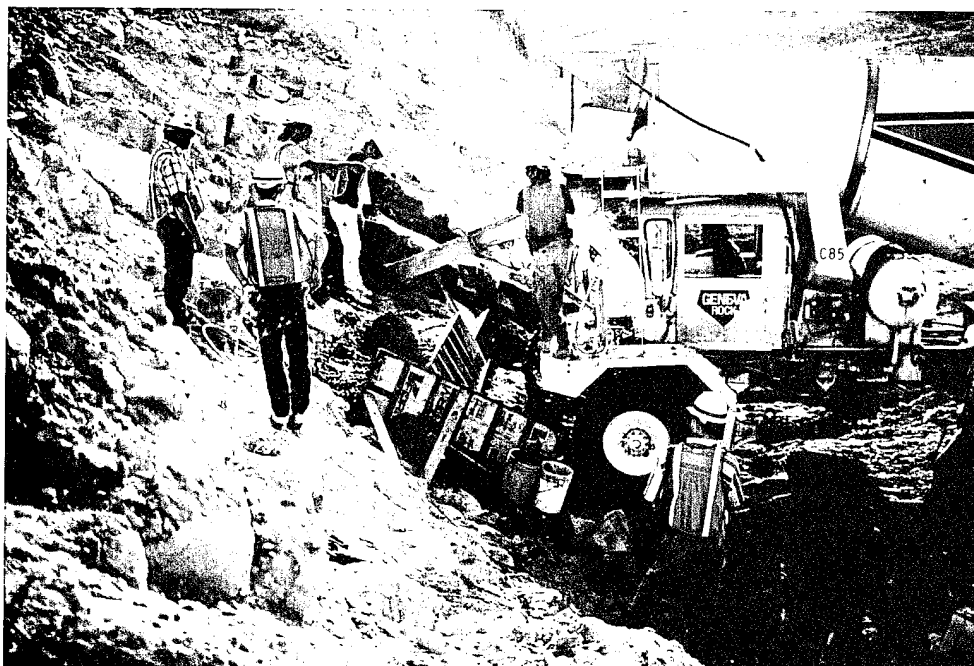
PHOTO CT23. Looking downstream at the placement of a concrete fillet at the left abutment core trench. Note form on near end to prevent thinning (feathering out) at the ends of the fillets.
